INDOOR AIR QUALITY ASSESSMENT

**North Andover Police Department
566 Main Street
North Andover, Massachusetts**

Prepared by:
Massachusetts Department of Public Health
Bureau of Environmental Health Assessment
May, 2001

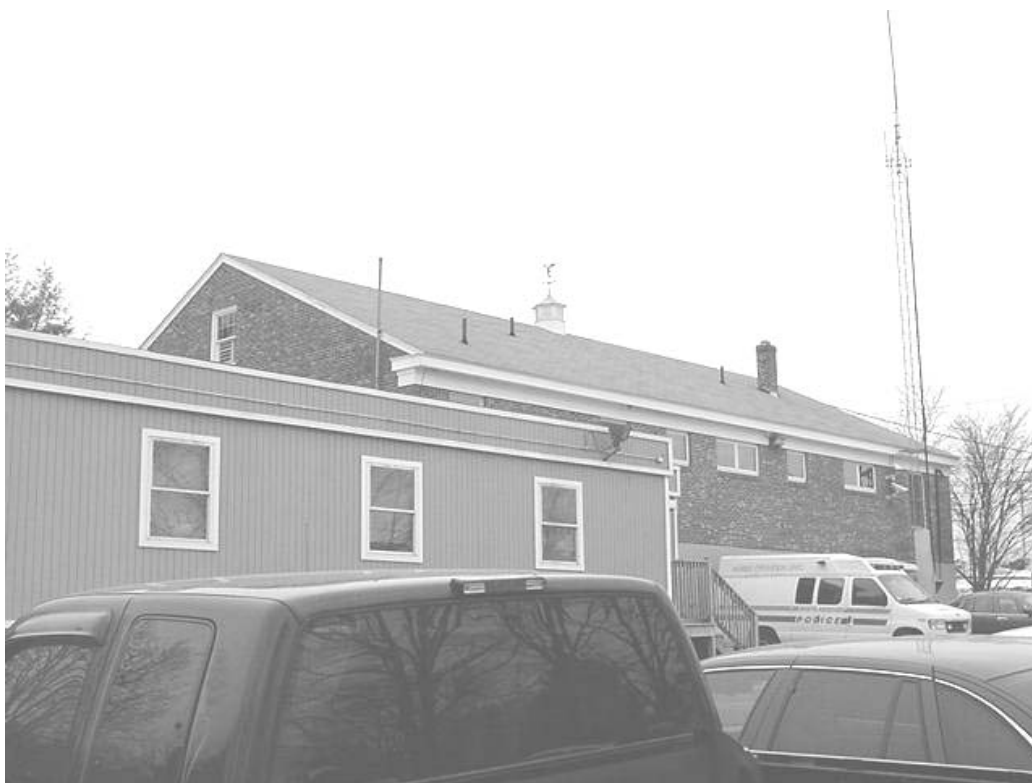
Picture 1

The NAPD is a one-story red brick building constructed in 1967. The building was renovated in the early 1990's during which a portable structure that houses the detective unit was attached to the rear of the building (see Picture 1). The ground floor of the NAPD consists of the dispatch area, prisoner-processing area, holding cells and office space for senior law enforcement officers and support personnel. Located in the basement are the police chief and secretary's offices, roll call room, locker room, restrooms, evidence room and the armory.

North Andover Police Department, Portable Detective Unit in Foreground

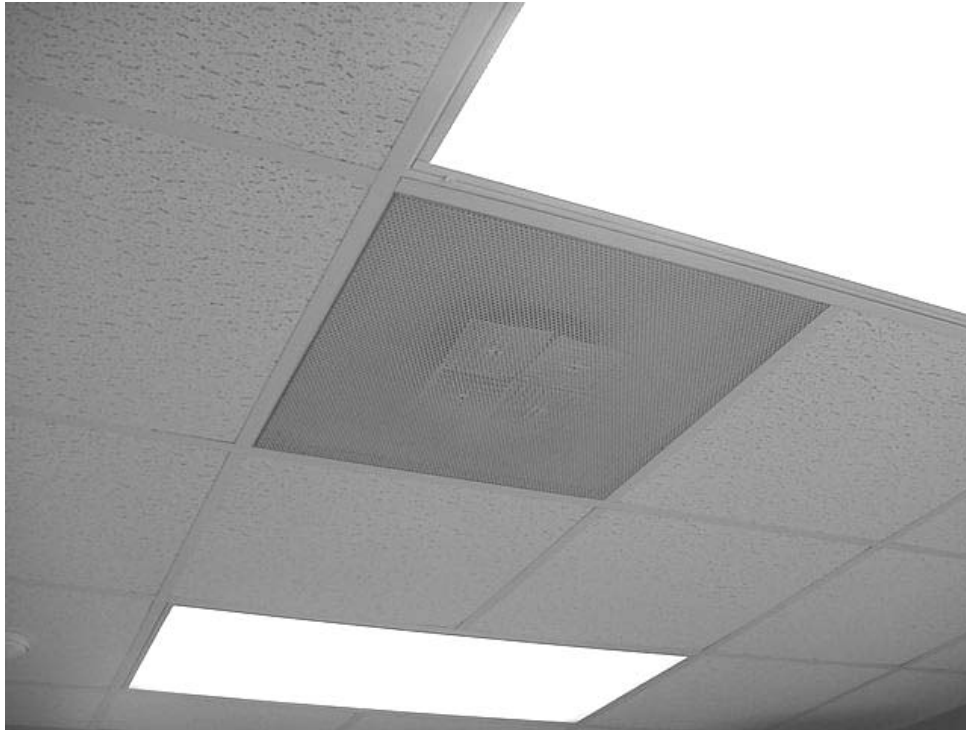
Picture 3

provides ventilation for the ground floor (see Picture 2) through ducted, ceiling vents (see Picture 3). Exhaust ventilation is provided by ceiling-mounted exhaust grilles, which return air to the AHU via ductwork (see Picture 4). The AHU has no means to introduce fresh air. In this configuration, the AHU only tempers and recirculates air within the police station. It appears that the building was originally designed to provide fresh air to interior spaces solely through openable windows.

Ceiling-Mounted Air Diffuser

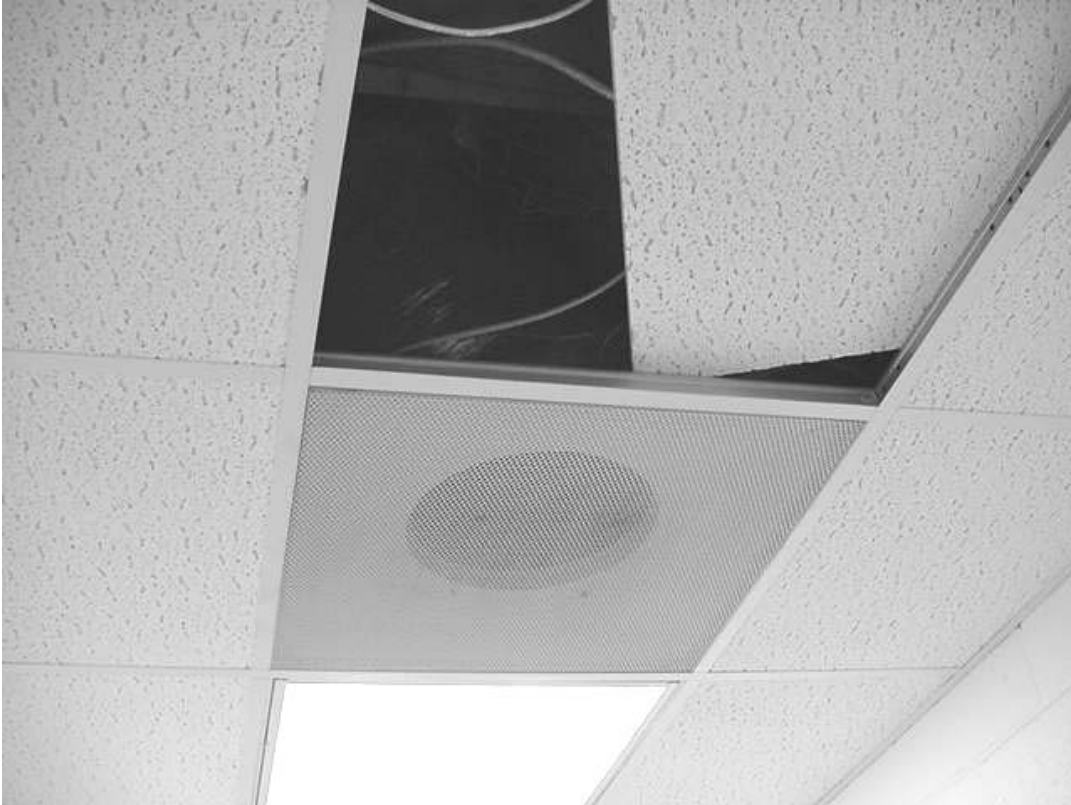
Picture 4

Ceiling-Mounted Return Vent

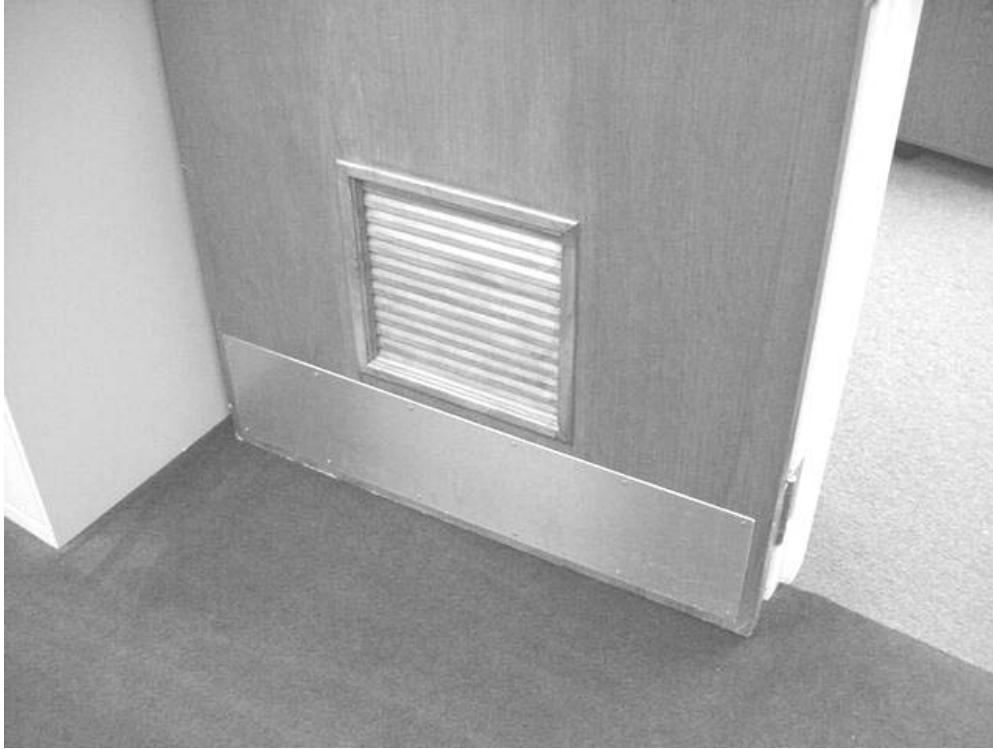
Picture 7

Ventilation for the basement storage areas and offices is provided by an AHU, which also had no provision for the introduction of fresh air. Exhaust ventilation for these areas is provided by a single wall-mounted return vent in the secretary's office (see Picture 6). Passive grills are mounted on doors (e.g., Chief's office & briefing room) to draw air into the secretary's office and out of the building through the exhaust vent located in the radio room (see Pictures 7 & 8). Carbon dioxide readings in these areas were slightly above 800 ppm, which as discussed previously can indicate inadequate air circulation. Mechanical exhaust vents in basement restrooms (including the Chief's office) were operating at the time of the assessment; however, each was drawing air very weakly and may not be sufficient to provide proper exhaust. In addition, exhaust ductwork for restroom vents must travel a great distance (across the entire length of the basement) then go through a series of 90° angles before reaching the exhaust

Passive Door Vent in Basement (Chief's Door)

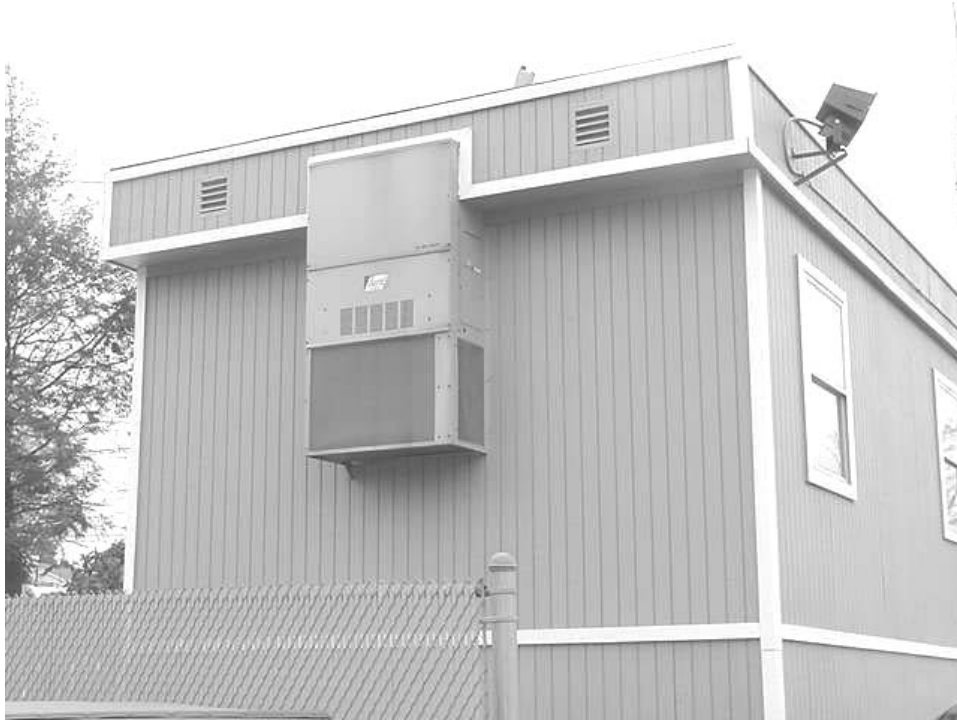
Picture 10

Ventilation for the detective unit is provided by a ducted air-handling unit (AHU) located on the exterior wall of the structure (see Picture 10). Fresh air is distributed to work stations via ductwork connected to ceiling-mounted air diffusers. Return vents draw air back to the units through wall or ceiling-mounted grilles (see Picture 11). A thermostat controls the HVAC system. The thermostat has settings of “on” and “automatic”. Thermostats were set to the “automatic” setting during the assessment (see Picture 12). The automatic setting on the thermostat activates the HVAC system at a preset temperature. Once the thermostat reaches a preset temperature, the HVAC system is deactivated. Therefore no mechanical ventilation is provided until the thermostat re-activates the system.

AHU for Detective Unit

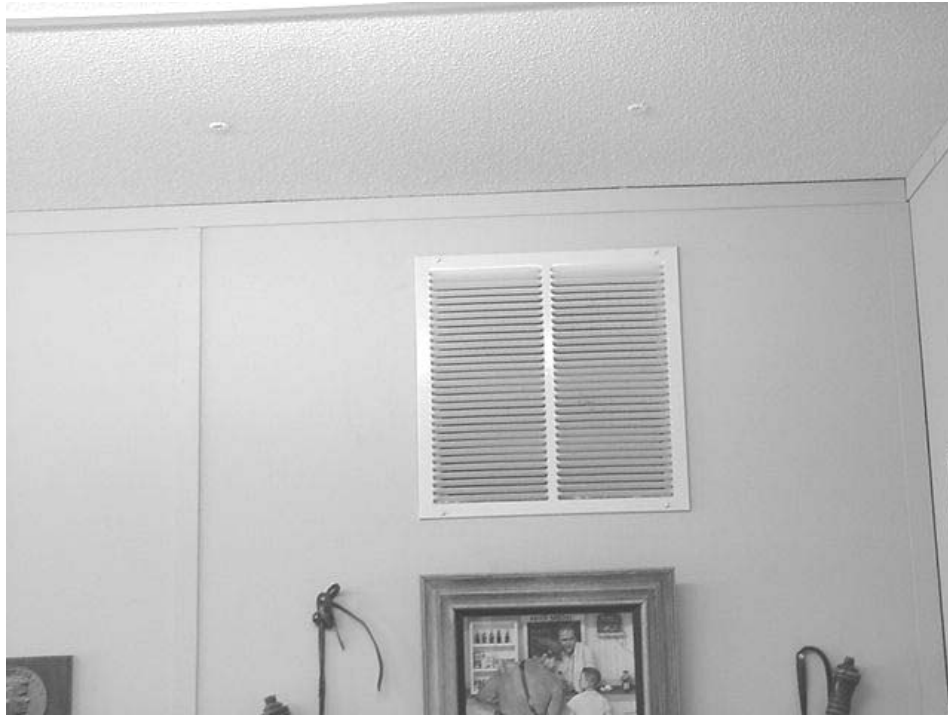
Picture 11

Wall-Mounted return Vent in Detectives Unit

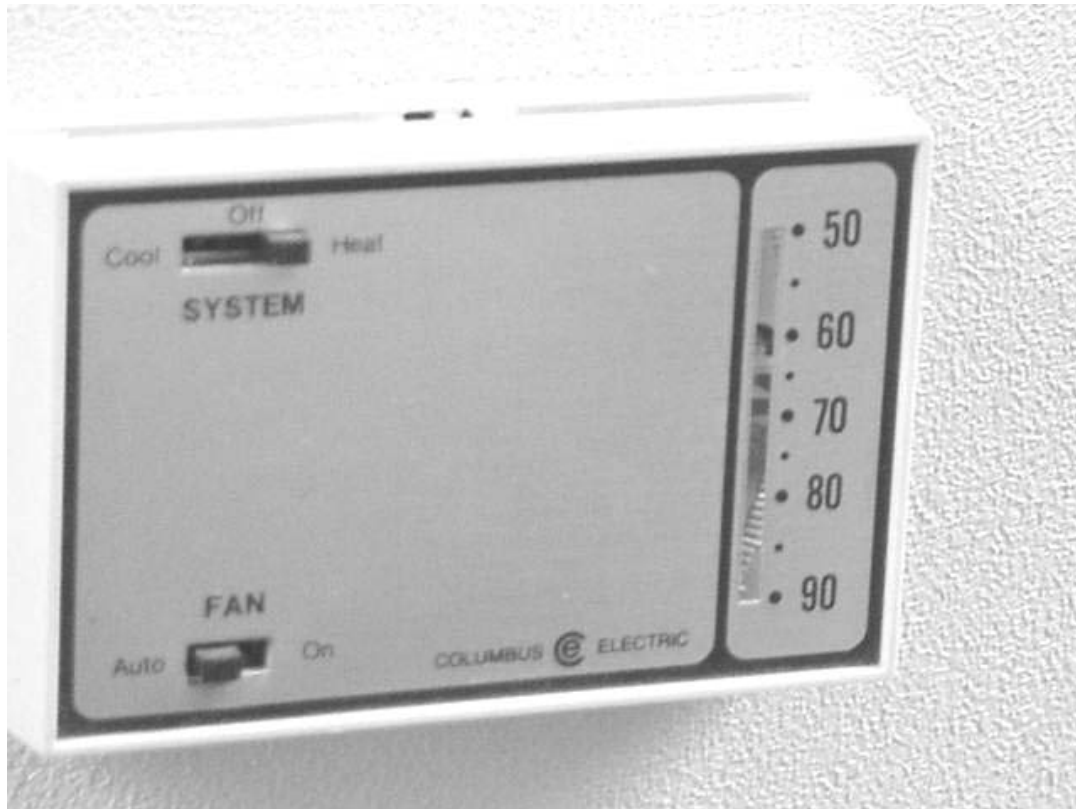
Picture 12

Thermostat Controlling AHU for Detectives Unit

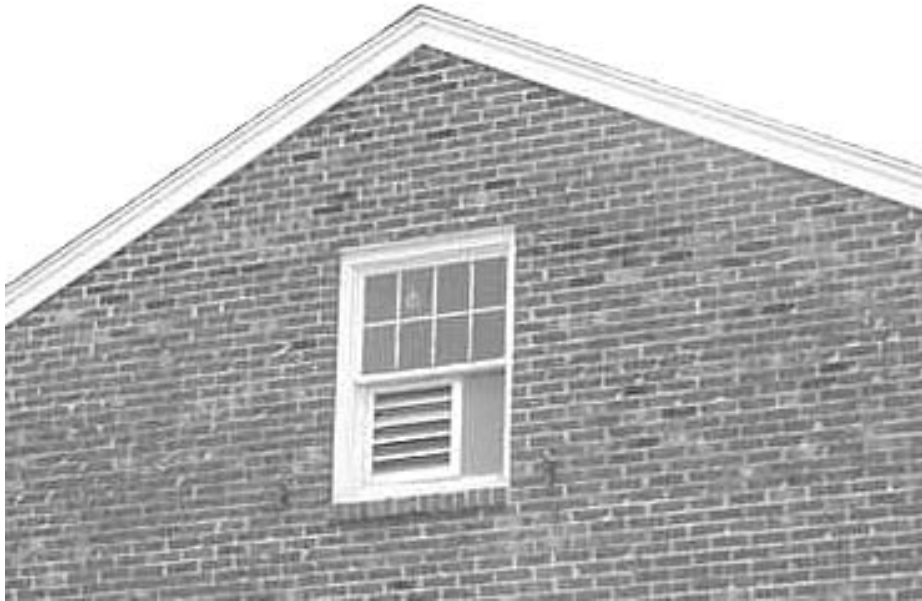
Picture 13

Exterior Shot of Attic Exhaust Vent
